**EQUIPMENT / FURNISHING
PASSENGER COMPARTMENT**

INSPECTION / REPLACEMENT OF EJECTOR BASE

**SERVICE BULLETIN NUMBER
504443-25-02
ISSUE 10**

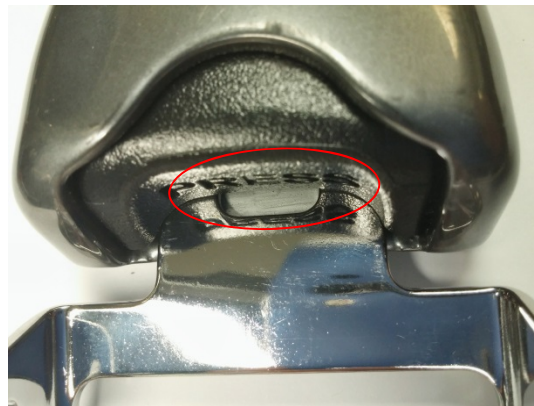
1. Completely insert the Connector into the Buckle as would be done during normal use. Visually check to see if the Connector is completely engaged within the Buckle. Figure 1 below shows a Buckle where the Connector is fully engaged. Figure 2 shows a Buckle where the Connector is not fully engaged. Notice the opening of the Connector is easily visible in Figure 4, whereas it is not in Figure 3.

Figure 4: Connector not Fully Engaged

If the Connector is able to be removed under force of hand, proceed with this Service Bulletin by following the directions in Warranty Section H, (a).

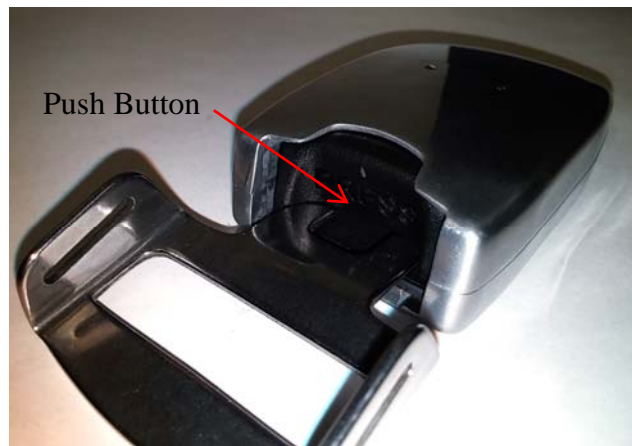
3. Cycle the buckle five Times. One cycle consists of inserting the connector completely and depressing the Push Button to eject the connector. In the event that the Push Button does not return at all when the Connector is inserted as seen in Figure 5, proceed with this Service Bulletin by following the directions in Warranty Section H, (a).

Figure 5: Push Button not Returning when Connector Inserted

- (a) Restraint System Assemblies containing one of the subject Buckle Assemblies should be:
1. Returned to AmSafe, Inc. together with a free of charge purchase order containing the following information:
 - Reference SB504443-25-02
 - Description
 - Part number
 - Quantity
 - Name of airline
 - Operator shipping details

2. Reworked per this service bulletin by ordering Ejector Base Replacement Kit P/N 506311-1. One kit contains enough components to address one buckle assembly as well as the instruction (P/N E506312) to perform work.
