## **SERVICE BULLETIN**

**EQUIPMENT / FURNISHING  
PASSENGER COMPARTMENT**

**INSPECTION / REPLACEMENT OF EJECTOR BASE**

**SERVICE BULLETIN NUMBER  
504443-25-02  
ISSUE 10**

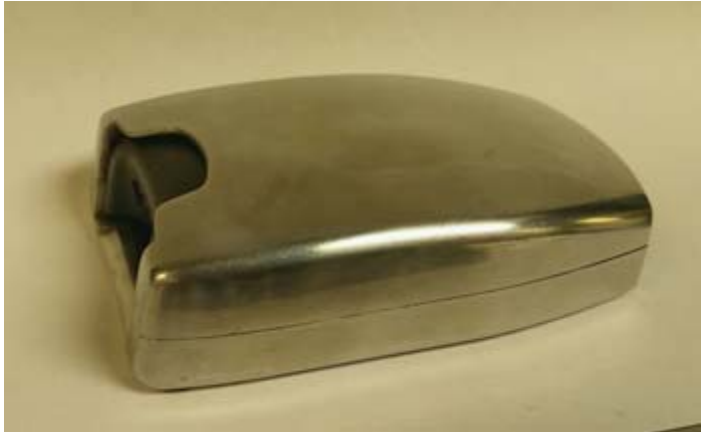
**Figure 1:** 504443-Series Buckle

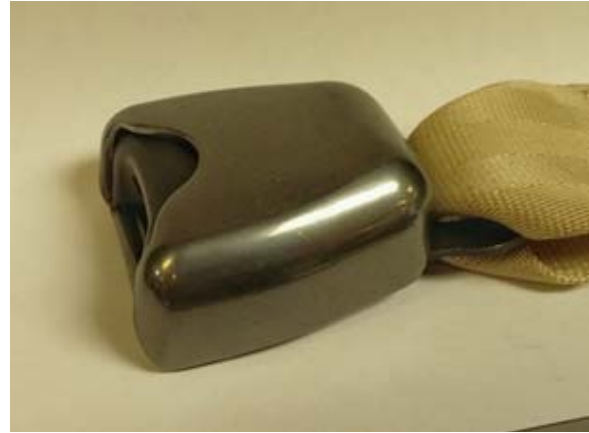
Inspections have found that the 505703-Series Compact End Release Buckle is not exhibiting the condition that was cause for the Service Bulletin. The reason for this is an as-cast feature that only exists in the Compact End Release Buckle Housing. This feature captures the subject Ejector Base, thereby not allowing the Ejector Base to deflect.

**Figure 2:** 505703-Series Buckle, Unaffected by Service Bulletin

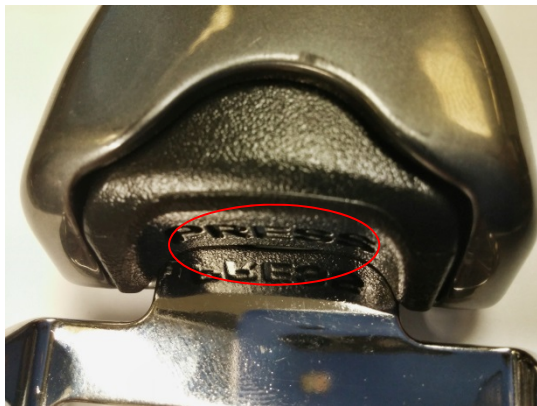
1. Completely insert the Connector into the Buckle as would be done during normal use. Visually check to see if the Connector is completely engaged within the Buckle. Figure 1 below shows a Buckle where the Connector is fully engaged. Figure 2 shows a Buckle where the Connector is not fully engaged. Notice the opening of the Connector is easily visible in Figure 4, whereas it is not in Figure 3.

**Figure 3:** Fully Engaged Connector

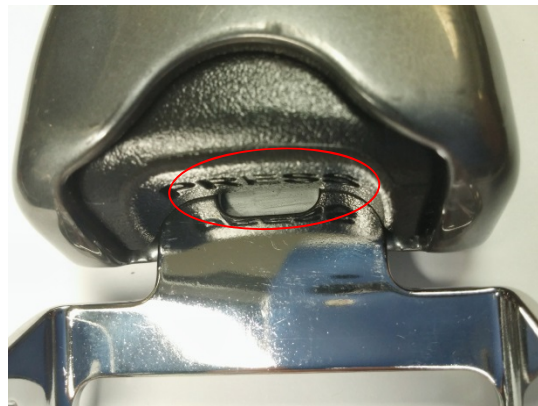
**Figure 4:** Connector not Fully Engaged

If the Connector is able to be removed under force of hand, proceed with this Service Bulletin by following the directions in Warranty Section H, (a).

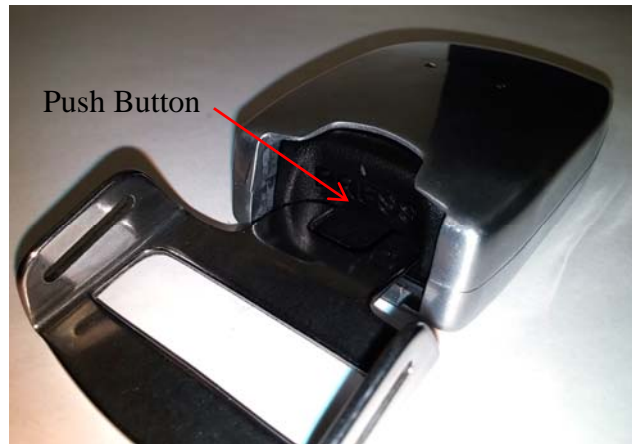
3. Cycle the buckle five Times. One cycle consists of inserting the connector completely and depressing the Push Button to eject the connector. In the event that the Push Button does not return at all when the Connector is inserted as seen in Figure 5, proceed with this Service Bulletin by following the directions in Warranty Section H, (a).

**Figure 5:** Push Button not Returning when Connector Inserted

2. Reworked per this service bulletin by ordering Ejector Base Replacement Kit P/N 506311-1. One kit contains enough components to address one buckle assembly as well as the instruction (P/N E506312) to perform work.
